# Manhole Inspection Summary

Manhole # S27CC\_040MH

Insp Date: **7/7/08 8:34 AM**

**Location** Address: **611 W LAFAYETTE AVE**

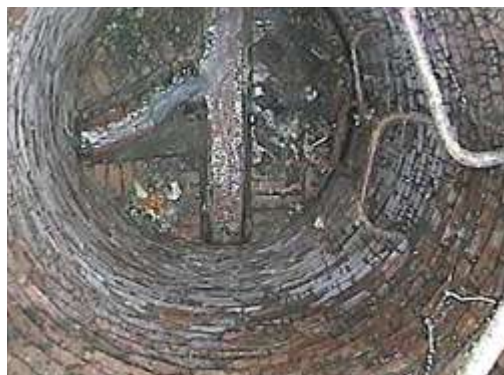
Top View

Comments **HOLE IS FILLED ALMOST TO THE TOP WITH DIRT**

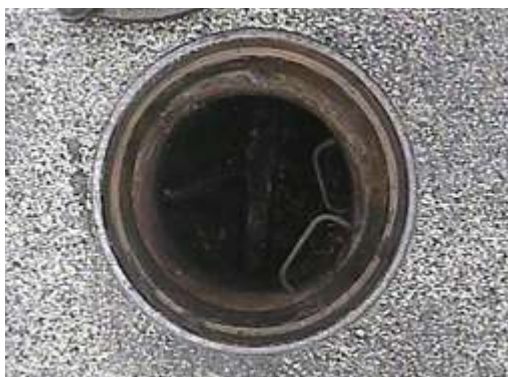
Defect 1

Offset: **1** (in.)

FRAME OFFSET

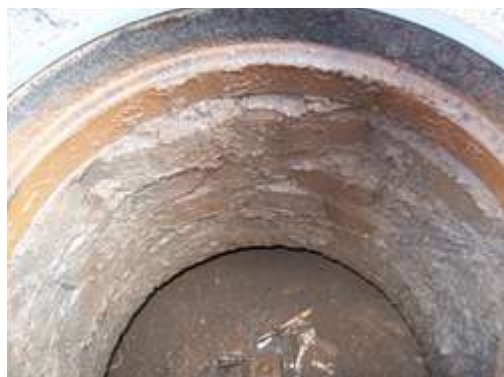
Defect 4

Condition: ☐ Sound ☒ **Cracked** ☐ Root Intrusion ☐ Loose Brick ☐ Deteriorated

CHIMNEY CRACKED

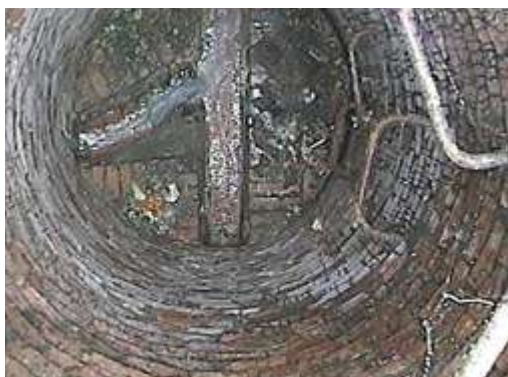
Defect 3

Count: **5** Missing: **0** ☒ **Corroded**

STEPS CORRODED

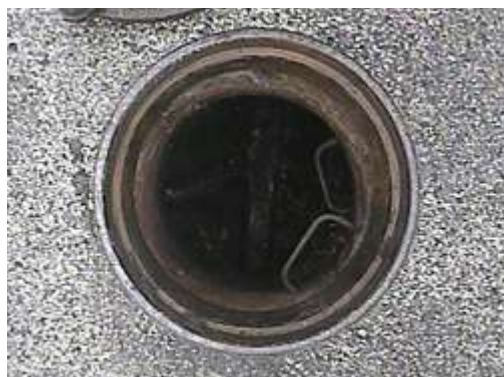
FRAME OFFSET
